WT-1631

PROVIDE TO EXISTING EPG STRUCTURES (U)

Release Date: October 27, 1964

(6) DAMAGE to EXISTING EPG STRUCTURES (U)

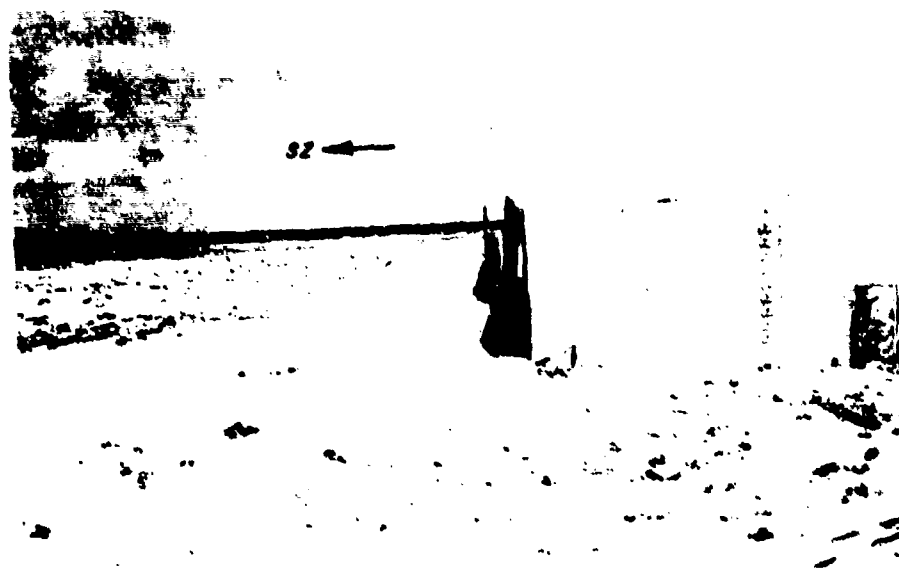
Pre- and post-Fir photographs (Figures 3.6 through 3.9) show the effect of water waves and

air blast on the immediate area. The telephone pole adjacent to the structure was broken at the roof line. Although the door of this structure could not be sealed tightly due to faulty seating, it is assumed that the pressure build-up within the station was slight. Three one-hundred-watt light bulbs fastened to the ceiling did not break, indicating that the pressure within the station was very low. Three inches of mud covered the floor and high water mark was noted 1 foot 8 inches above the floor. The sand bags were strewn about the entire area, the top of the berm was lowered 2 feet, and the earth mound in front of the station was reduced 7 feet in height. Indications were that at least 3 feet of water had been confined within the circular berm area. Pre-Fir, post-Fir, and post-Sycamore profiles of the island between Stations 560.01 and 1519 are shown in Figure 3.10.

Figure 3.8 Post-Fir, (Item 2) Station 560.01. Pressure level: Fir, 30 psi.

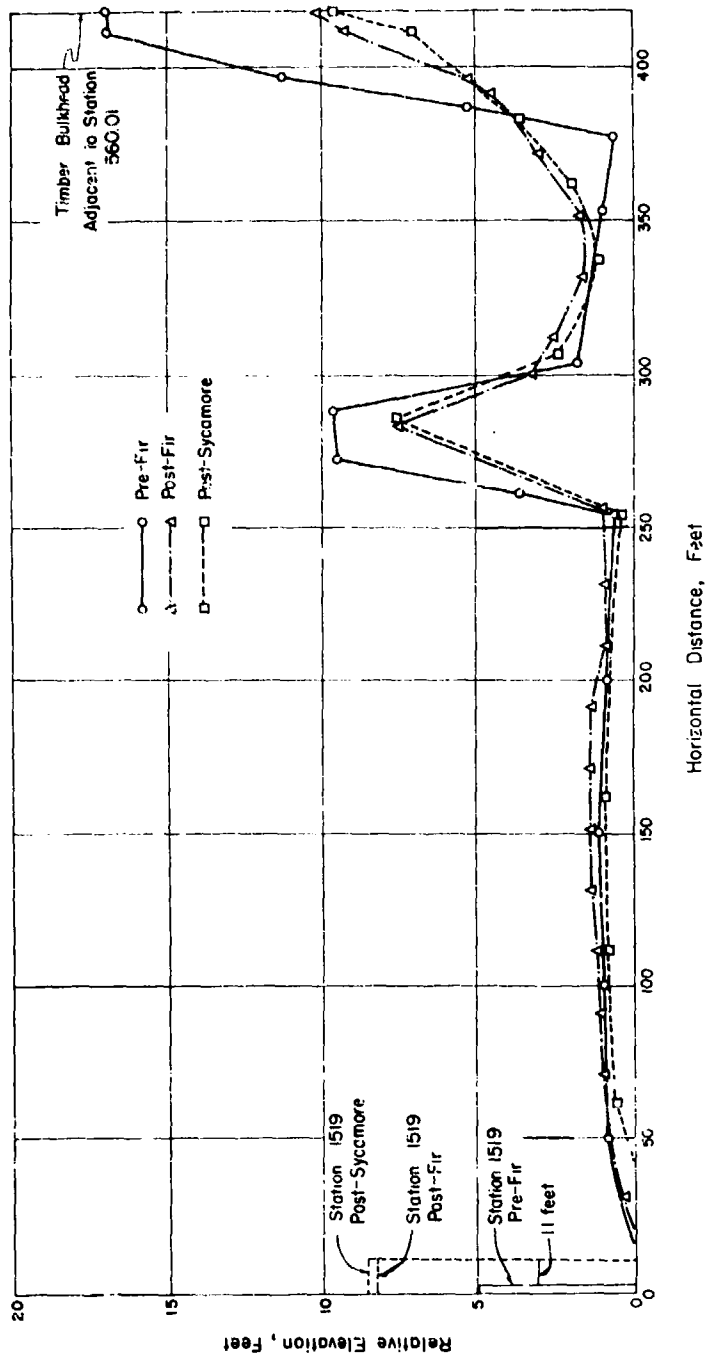
evident from Figure 3.10 that Shot Sycamore caused very little, if any, additional erosion.

Figure 3.10 Ground-surface profile between (Item 2) Station 560.01 and (Item 4) Station 1519.

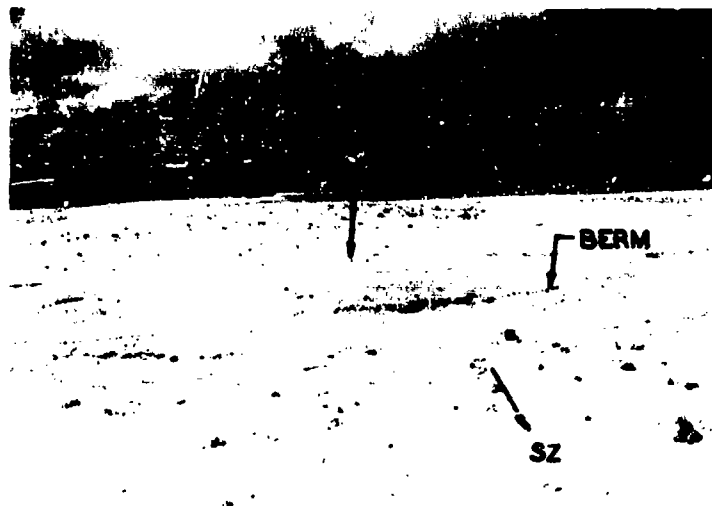
Figure 5.11 Post-Poplar, (Item 2) Station 560.01, complete destruction of station. Station 1341 can be seen in background. Pressure level: Poplar, 1,200 psi.

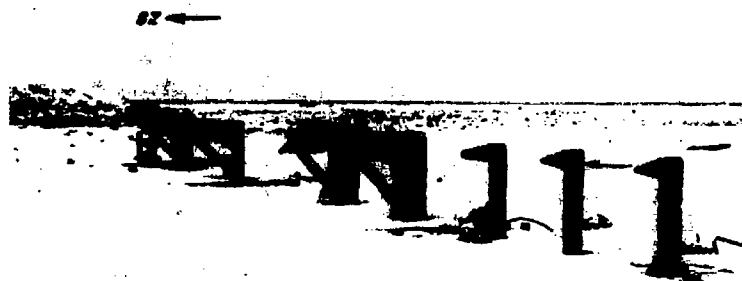
These stations received an estimated air pressure of 30, 6, 12, 10, and 1,200 psi from Shots Fir, Sycamore, Aspen, Cedar, and Poplar, respectively. The stations were undamaged from the first four shots except for slight erosion of the soil around the concrete foundations, (Figure 3.12); however, the force from Shot Poplar destroyed the steel drag members, leaving only the concrete bases (Figure 3.13).

Figure 3.12 Post-Fir, (Item 3) Stations 152.01 and 153.01. Pressure level: Fir, 30 psi.

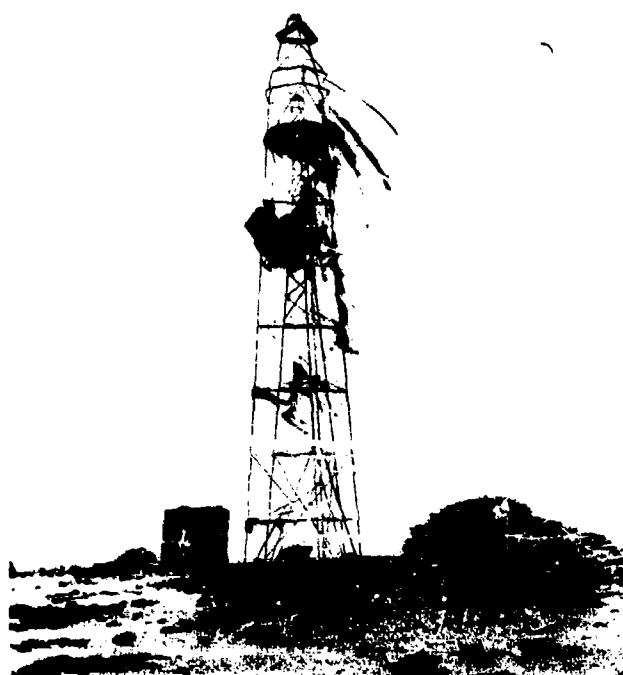
The air blast and water wave from Shot Fir swept nearly all vegetation from the island. Inundation caused from Shot Fir extended past Station 78.01 as can be seen in Figure 3.16. A light steel tower, shown in Figure 3.17, was located in the 25-psi air-overpressure range of Shot Fir and was completely destroyed, leaving no trace of the structure.

Figure 3.17 Preshot, steel tower on Site Charlie; completely destroyed by Shot Fir, 25 psi.

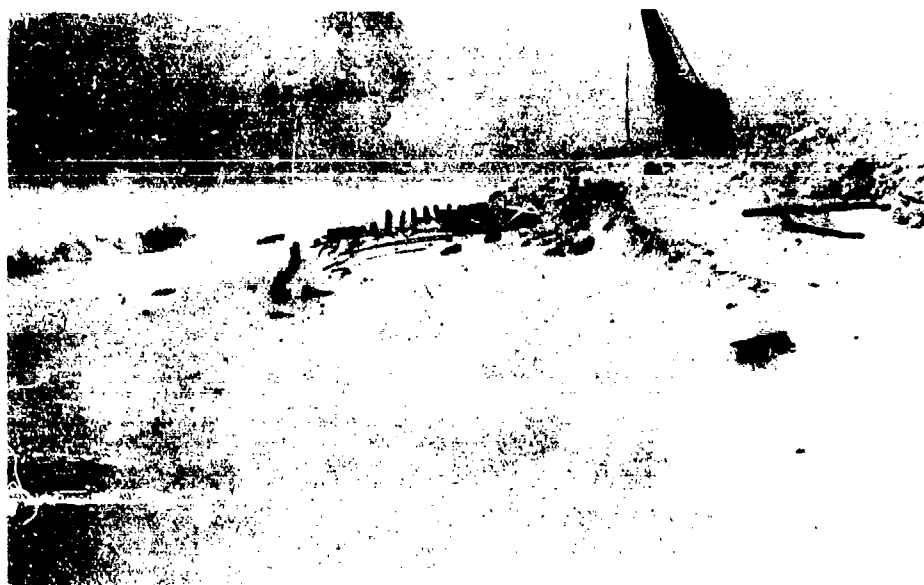
Figure 3.35 Post-Nutmeg view of timber bulkhead and sand bags at west end of Site Tare. Pressure level: Nutmeg, 650 psi.

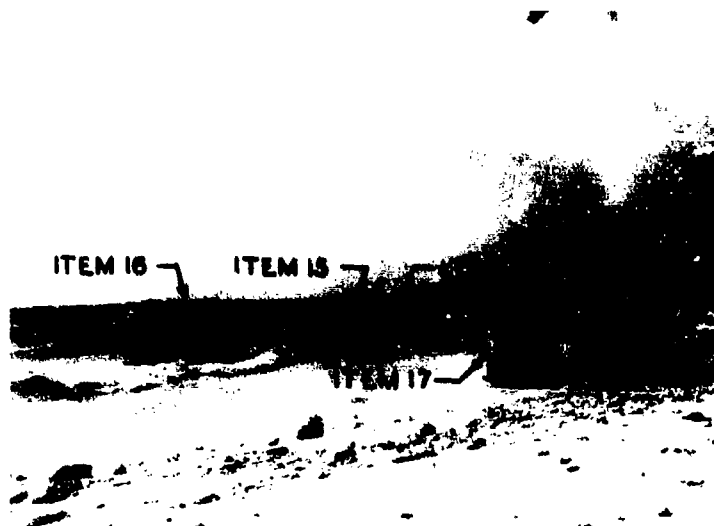
This station was located in the estimated 490-, 260-, and 1,400-psi overpressure range for Shots Nutmeg, Hickory, and Juniper, respectively. Even though the station was exposed to extremely high overpressures it was not damaged structurally. A post-Juniper view of this structure is shown in Figure 3.36.

Figure 3.36 Post-Juniper view of east end of Site Tare looking toward surface zero.

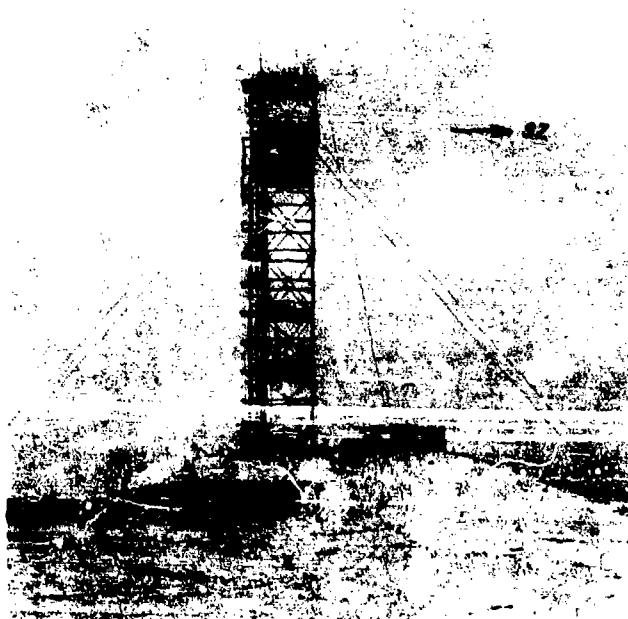
Figure 3.37 Post-Nutmeg, (Item 12) Stations 2200 and 2250.

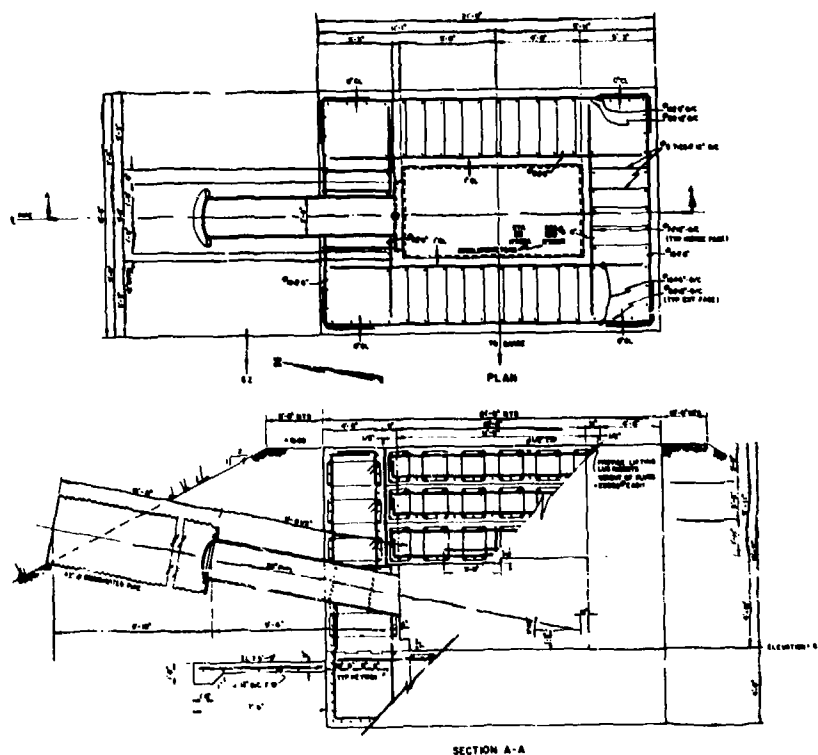
Figure 3.41 Plan and elevation including the location of self-recording accelerometers for (Item 16) Station 2230.02, Site Tare.

3.4.4 Item 15, Station 2230.01. A reinforced-concrete detector structure was constructed during Operation Hardtack (1958). For practical purposes the plans for this station were the same as those shown in Figure 3.41 for Station 2230.02 except that the walls were 6 inches greater in thickness.

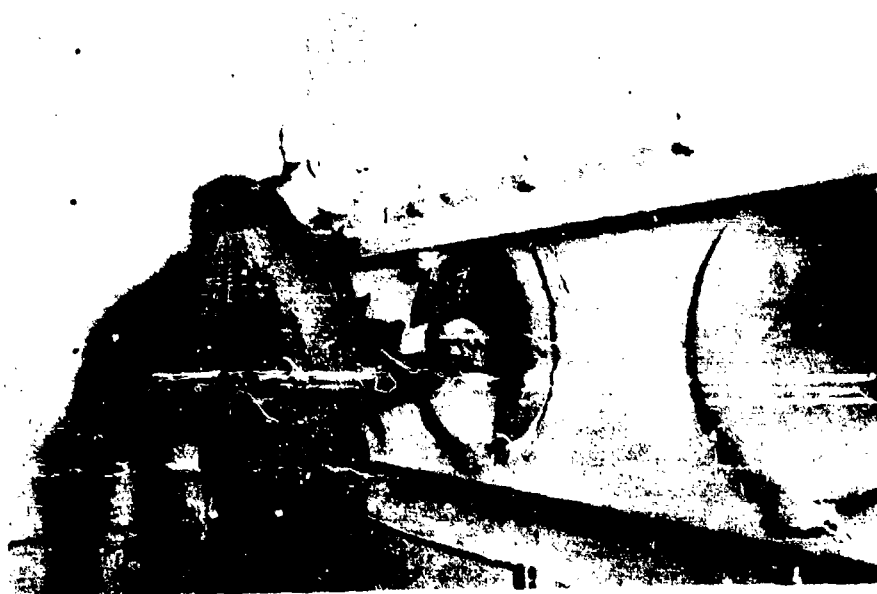
The plain-concrete floor of this station was badly cracked and the five 24-inch pipes entering this station were forced inward about $2\frac{1}{4}$ inches (Figure 4.18). The crack pattern (shown in Figure 4.19) indicates that the existing foundation underneath part of the floor gave additional support to that portion.

Figure 4.18 Post-Koa, (Item 20) Station 1311, 24-inch steel
pipes pushed inward $2\frac{1}{4}$ inches. Pressure level: Koa, 42 psi.

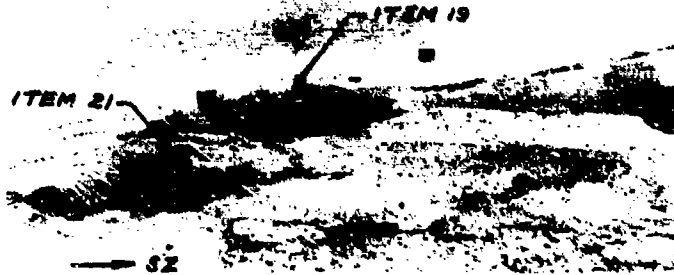
The highest pressure received by this station was an estimated 43 psi from Shot Koa. The structure was not damaged structurally by any of the shots. However, the earth cover on the

side of the structure facing surface zero for Shot Walnut was blown and washed away, exposing the concrete wall surface (Figures 4.20 and 4.21).

Figure 4.21 Post-Walnut, (Item 21) Stations 1211 and 1410, view of exposed side wall. Pressure level: Walnut, 26 psi.

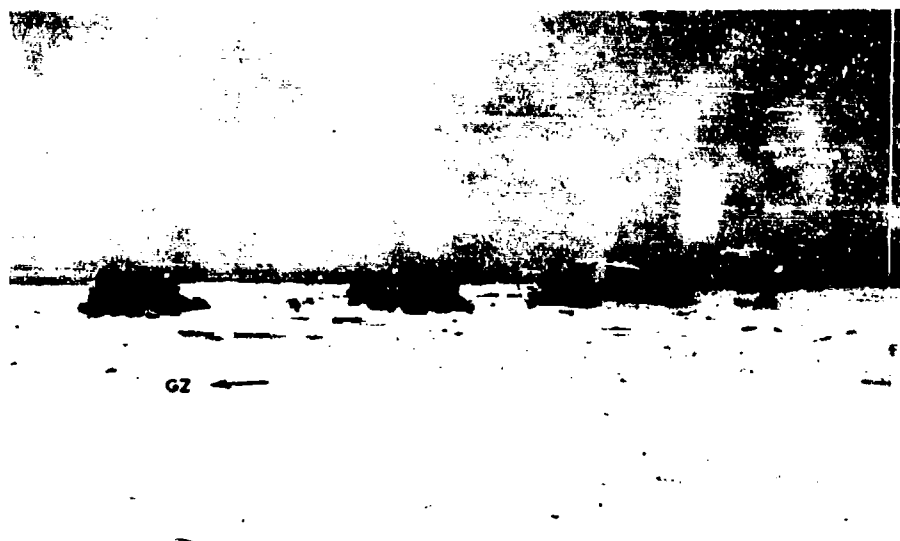
The earth mound approximately 15 feet above the ground surface for the station complex shielded the generators from the air blast to varying degrees. The generators were located approximately 40 feet from the intersection of the mound with the ground surface. The generator near the edge of the mound (least protected from air blast) was thrown 60 feet while the gen-

erator nearer the center of the mound (most protected) was moved 2 feet. The other two generators were thrown distances of 20 and 40 feet. A postshot view of the four generators is shown in Figure 4.28 and a close-up of one of the generators is shown in Figure 4.29. No additional damage to or movement of the generators occurred as the result of Shots Yellowwood (11.5 psi) or Tobacco (1.8 psi). The Na. / pontoon sections were not damaged from any of the shots; however, the air blasts from Shots Koa and Yellowwood moved the sections approximately 100 feet. Both the generators and pontoon sections underwent additional movement during Shot Walnut (28 psi). Movement from the remaining shots was not observed.

Figure 4.28 Post-Koa, (Item 23) generators. Pressure level: Koa, 38 psi.

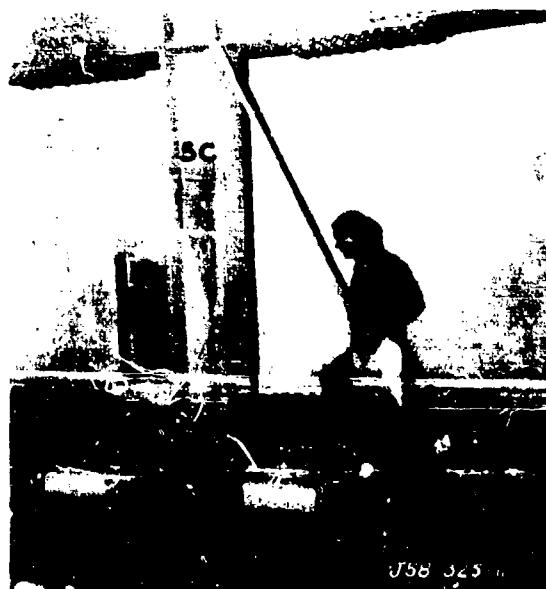
Figure 4.49; this picture also shows the suspended plumb bob that was used in measuring column offsets. The roof in Building 6 lifted upward 3 to 4 inches, tapering to its normal position at a point 7 or 8 feet from the front wall (Figure 4.50). The cracked roof section in Building 4 opened considerably, being displaced a maximum of 10 inches at the center of the section adjacent to Column Line 10 and the north end of the building (Figures 4.51 and 4.52). The bottom bars (No. 4) of the slab failed in tension as was noted by the neck-down of the bars at the point of breakage.

Figure 4.49 Post-Walnut, (Item 26) Station 3.1.1, Column 5C, first floor of Building 2. Pressure level: Walnut, 16 psi.

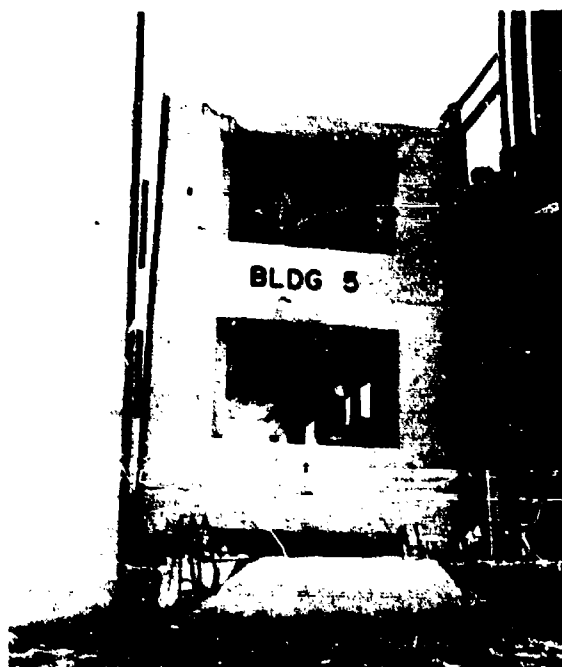
Shot Elder (pressure level of 20 psi) caused additional damage as can be compared by viewing Figures 4.53 and 4.54 with Figure 4.40. The shear resistance of the first-floor columns of Building 5, the concrete frame, drag structure, was overcome and the upper floors intact settled down with the second floor girders resting on the collapsed first floor columns (Figure 4.55). The column offset measurements for Buildings 2, 3, and 6 are shown in Table 4.5. A front view of Buildings 1, 2, and 3 is shown in Figure 4.56. Building 3, the reinforced-concrete (diffraction) structure underwent additional permanent lateral movement, but unlike its counterpart, Building 5 (drag-type structure), the columns on each floor displaced laterally approximately the same amount and showed signs of damage (Figures 4.57, 4.58, and 4.59). The rear wall of Building 3 cracked horizontally, evidently from bending (Figure 4.60). Buildings 2 and 6 deflected approximately $\frac{1}{2}$ inch away from surface zero. However, most of the roof section of Building 6 was blown upward by the blast and thrown to the ground surface to the rear of the structure (Figure 4.61). Channel shear keys welded to the roof girder are also visible in the picture as well as the damage to the roof at the south end of Building 4. The major damage to Building 4 occurred at the north end where the roof was punched inward and is supported by the cantilever effect of the reinforcing steel (Figures 4.62, 4.63, and 4.64).

Figure 4.55 Post-Elder, (Item 26) Station 3.1.1, close-up of Building 5, first floor collapsed. Pressure level: Elder, 20 psi.

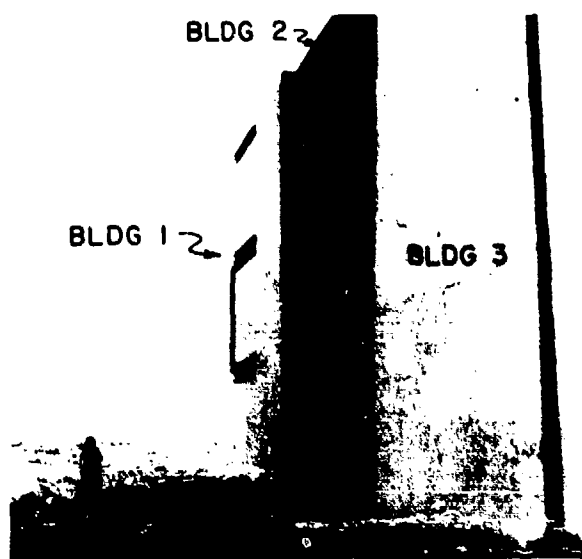
Figure 4.56 Post-Elder, (Item 26) Station 3.1.1, close-up of Buildings 1, 2, and 3. Pressure level: Elder 20 psi.

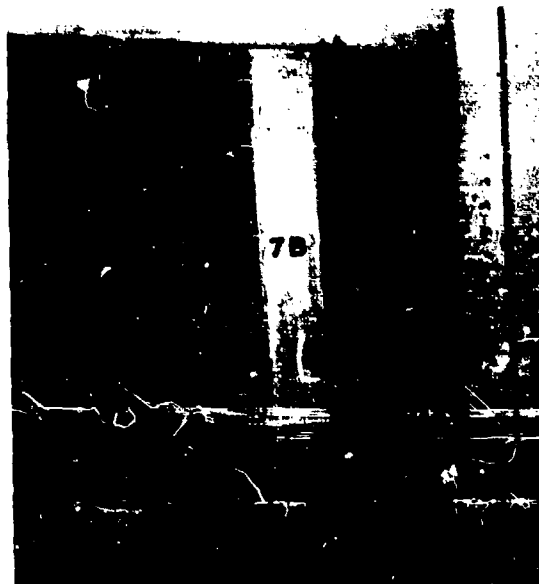
Figure 4.59 Post-Elder, (Item 26) Station 3.1.1,
Columns 7 and 8B, third floor of Building 3.
Pressure level: Elder, 20 psi.

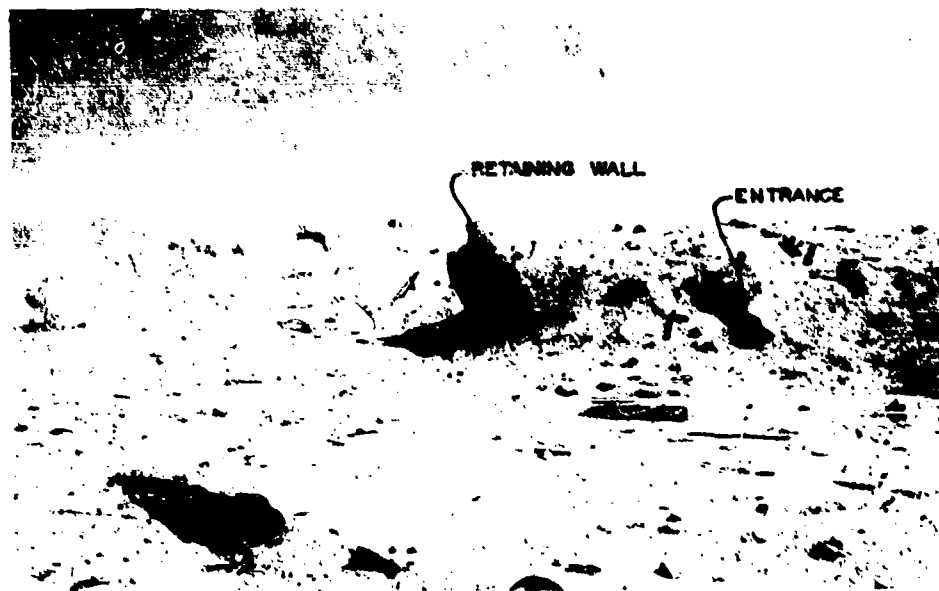
This station was located in the 1,600-psi air-overpressure range for Shot Cactus. As a result of the surcharge from this overpressure the timber entrance tunnel was filled in with sand and the adjoining retaining wall cracked and tilted outward 2 to 3 feet. A preshot view of the retaining wall is shown in Figure 4.88 and a post-Cactus view showing both the retaining wall and the entrance to the station is shown in Figure 4.89.

Figure 4.89 Post-Cactus, (Item 34) Station 1612, retaining wall and entrance to station. Pressure level: Cactus, 1,600 psi.

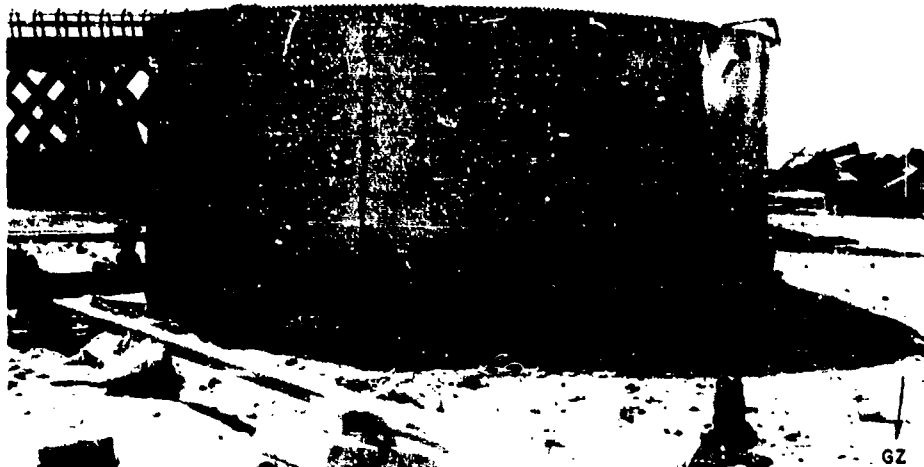
The tank was located in the 1.5-, 6.5-, 2.4-, 7.0-, 2.5-, 3.4-, 2.3-, and 3.4-psi air-overpressure zones for Shots Cactus, Butternut, Holly, Magnolia, Rose, Linden, Sequoia, and Pisonia. The tank was not affected by Shot Cactus but was damaged by Shot Butternut as shown in Figure 4.96. The tank was half full of water at that time. Shot Holly had no additional effects. The tank was damaged additionally by Shot Magnolia as seen by the local buckling failure around the top perimeter and the dishing of the roof as shown in Figure 4.97. No additional damage from the remain-

Figure 4.96 Post-Butternut, (Item 37) 21,000-gallon water tank.
Pressure level: Butternut, 6.5 psi.

ing shots was observed. Even though the tank was badly dented near the upper rim none of the bolts or bolt holes showed signs of incipient failure, and it appeared that the tank with some minor repairs could easily be placed in use again. The above-ground connections of 4-inch and 2-inch water pipes and the exposed 4-inch, rising-stem, gate valves (125-psi rated) were undamaged.

A 21,000-gallon water tank (Item 37) directly exposed to 6.5 and 7.0 psi of air overpressures received light damage. The roof was dished in, and there was a small amount of buckling of the sides above the level of liquid in the tank. In addition, it was noted that there was no damage to the exterior connecting piping.

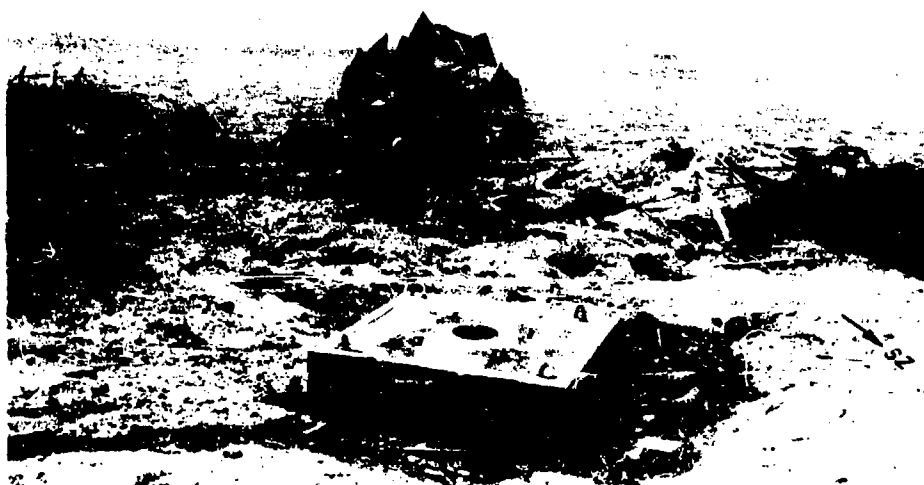
Figure 4.102 Post-Butternut, radar reflector. Pressure level: Butternut, 5.8 psi.

Radar Reflector. A multiunit, radar reflector, undamaged from the effects of Shot Cactus, was ripped from its concrete foundation and thrown 50 feet from the effects of Shot Butternut. A view of this station, which was located in the estimated 5.8-psi range from Shot Butternut, is shown in Figure 4.102.

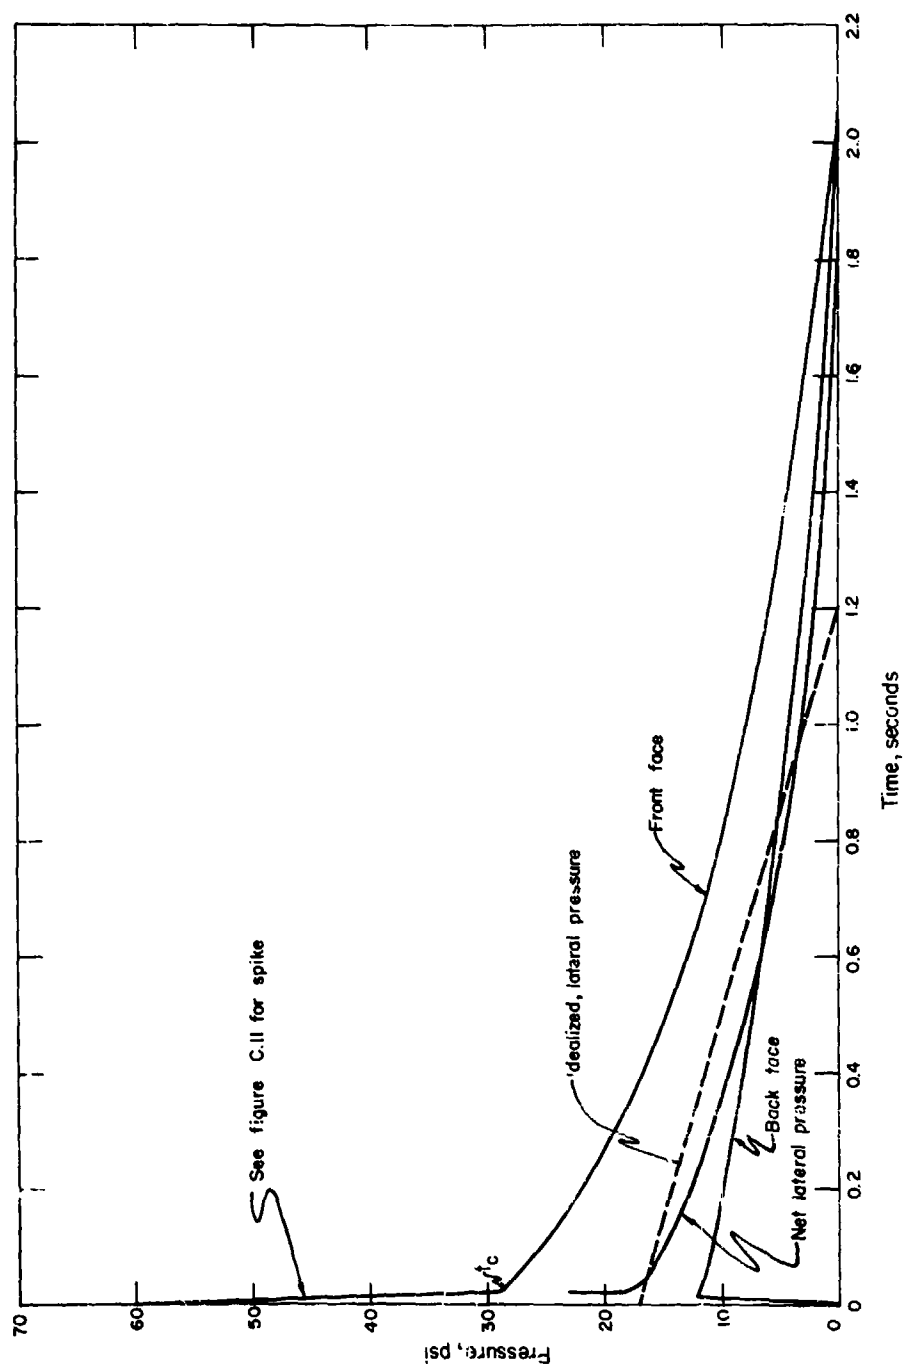
Figure C.9 Effective blast pressure on Station 20-D.

Since the net predicted pressure to cause failure was 29 psi and the actual pressure was 61 psi, the beam should have failed from the spike load alone. Idealized lateral pressure (without the spike load):

The pressure of 17 psi was sufficient to cause failure of the beam.

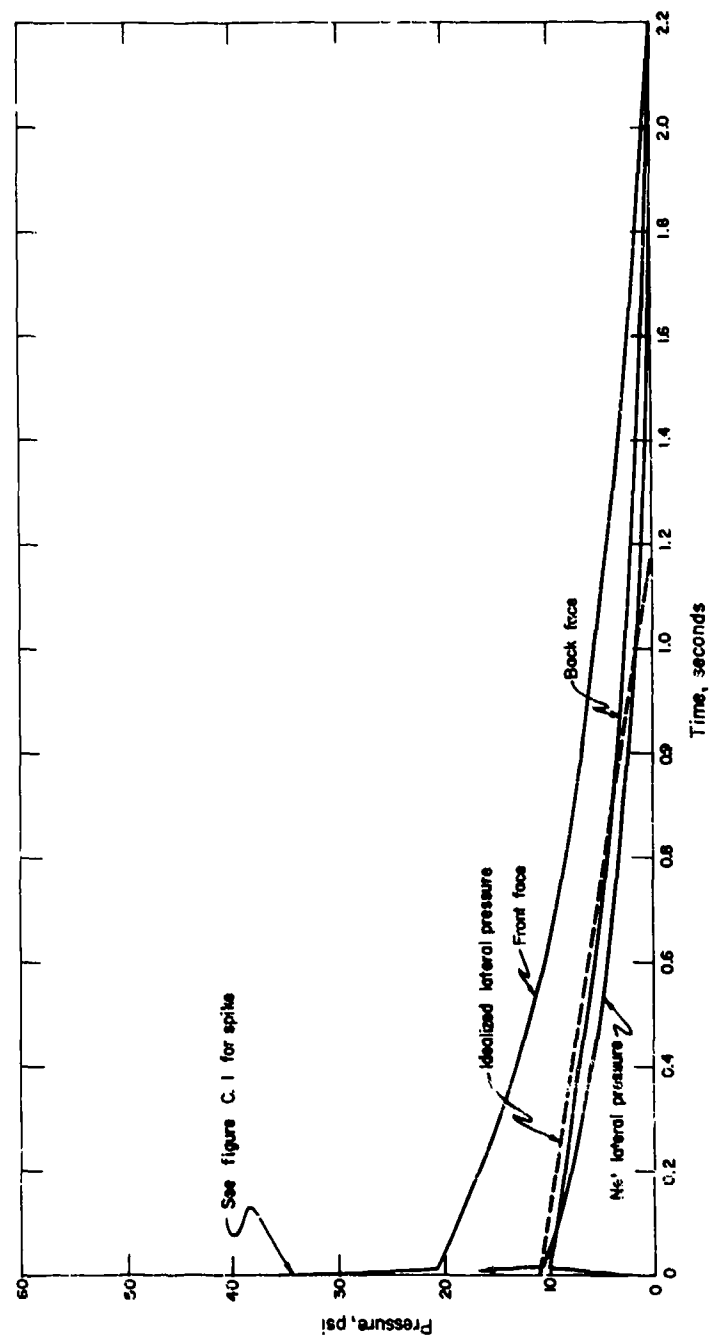
Figure C.10 Effective blast pressure on Station 20-F.

Since the actual pressure was 51 psi the beam should have failed according to the above calculations; however, the beam did not fail.

The net predicted pressure of 11.0 psi and the minimum pressure of 10.9 psi to cause failure are very close, and it can be assumed that due to this loading the beam

was very close to failure.

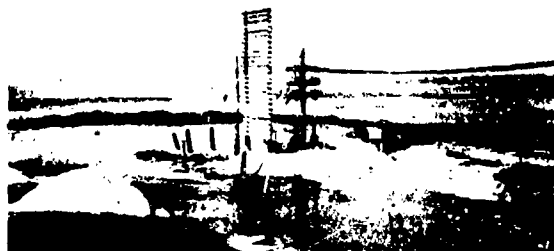
line so that water runs inland to great distances. Protective works can dissipate much of the energy of the water on shore but flooding of large land areas cannot be prevented.

Figure D.5 Transformer station after wave action ceased and water subsided. Shot Oak, Site Elmer.

works offer reasonably adequate protection against impact and drag effects by dissipating wave energy. The long period of blast-generated waves makes protection from inundation very difficult. Inundation and
